The Fourth season of Excavations at VIII.7.1-15 and the *Porta Stabia* at Pompeii: Preliminary report¹

Steven J.R. Ellis - Gary Devore

The Pompeii Archaeological Research Project: *Porta Stabia* (PARP:PS) recently completed its fourth campaign of excavations during which six trenches were excavated across the extent of VIII.7.1-15 (with one of these opened within the *vicolo* south of the *Odeon* at doorway 16). This fourth season was especially successful in that we are now able to clearly detect an overall phase plan for the entire *insula* thanks to the accumulated physical and stratified connections between several phased trenches from all seasons of our excavations, a primary goal for the season. To that end, all 2008 trenches were strategically located to aid in the definition of certain properties, and to recognise the spatial relationships within and between such buildings (fig. 1). Trench 16000 was opened in the courtyard of property VIII.7.6; trench 17000 was located in the entire rear room of VIII.7.7-8; trench 18000 was opened in the front room of VIII.7.12; trench 19000 was opened in the rear kitchen of VIII.7.9-11; trench 20000 was opened in the *vicolo* between *in

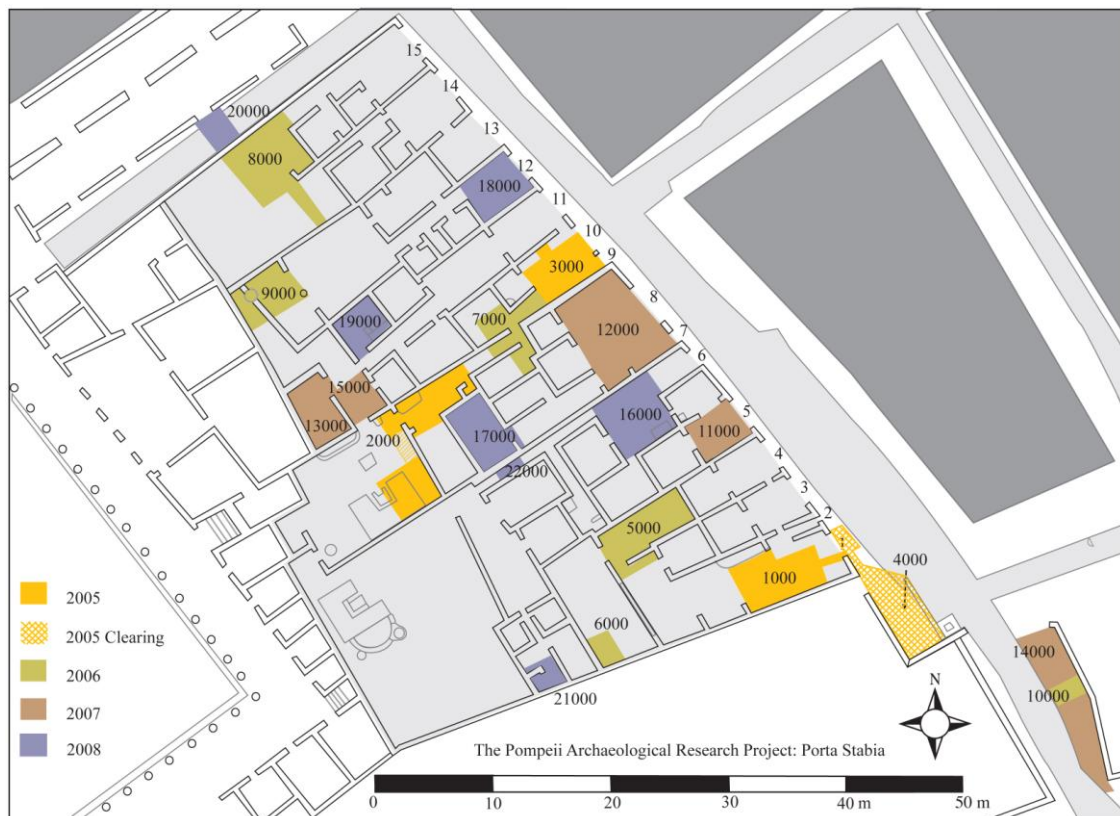
Fig. 1. Location of all trenches.

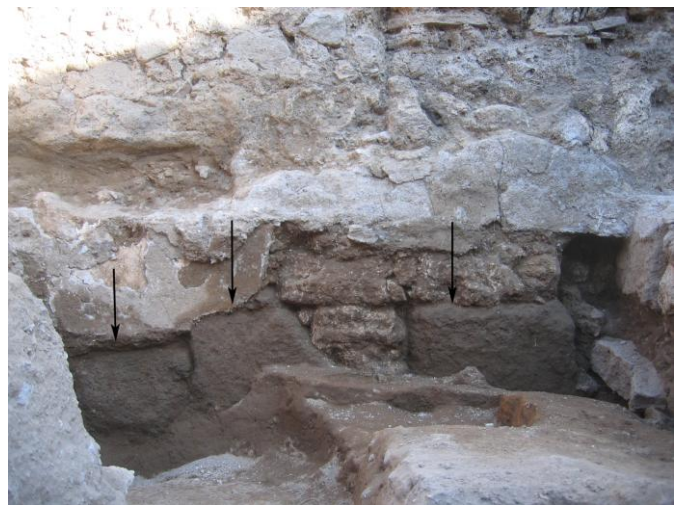
Fig. 3. The three pappamonte blocks below WF 108 (looking south; for scale see fig. 5).

The most abundant evidence for the earliest construction activity in this *insula* comes from the pappamonte foundations found in Trench 16000. The foundations consisted of two parallel stretches of pappamonte blocks – three in one wall (below WF 108; figs 3 and 5), a single block in the other (below WF 187; fig. 4) – that were laid down not later than the second half of the 4th century BCE and preserved by their reuse as foundations for later walls. The row of three pappamonte blocks uncovered in the base foundations of the later WF 108 was particularly interesting as its construction, or use, was associated with a ritual deposit. Cut into the same earthen surface that was related with this pappamonte wall was a small and shallow rectangular pit (10-15 cm deep; fig. 5), which was subsequently filled with

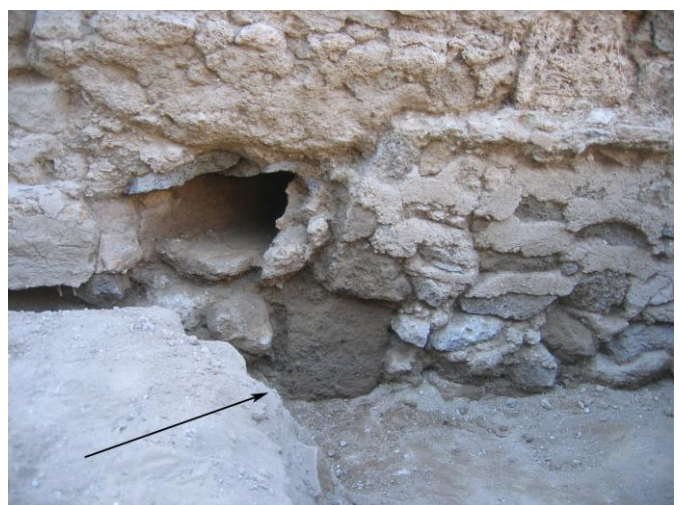
Fig. 4. Single pappamonte block below a later drain in WF 187 (looking north).

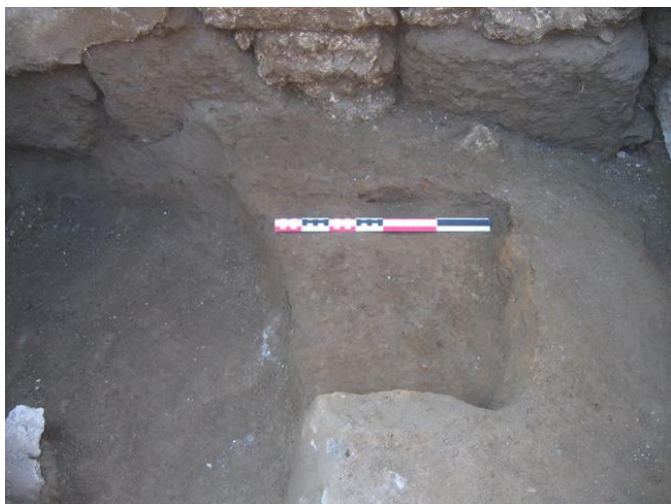
Fig. 5. Small ritual pit cut into a surface associated with the row of pappamonte blocks below WF 108 (looking south).

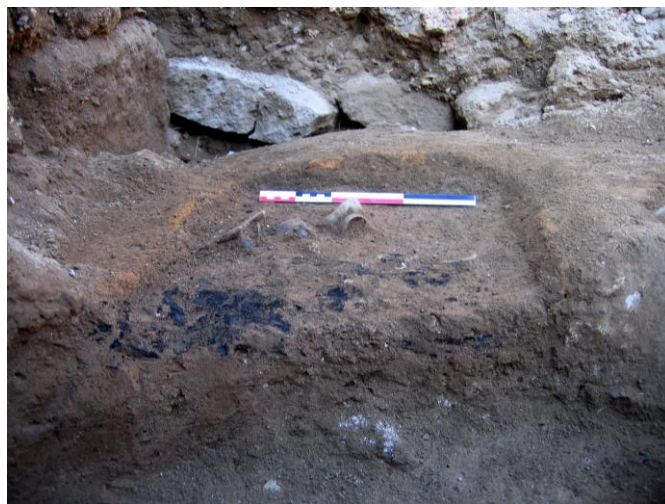
Fig. 6. Burnt ritual deposit found within the pit from fig. 5 (looking west).

a densely burnt deposit that contained the remains of a small meal and some Black Gloss Ware (which provided the dating evidence for the walls; fig. 6)².

The meal itself was remarkable. Its remains contained not only fish bones, grape seeds and shells of thin-walled nuts which are quite common around the site, but also burnt chicken bones and burnt limpet shell (neither of which have ever been uncovered in our excavations of this *insula*) as well as either burnt pig or burnt sheep/goat bones (rare in our excavations); some unburnt specimens of each of these classes of material were also recovered from this context. The burning was substantial and inconsistent with cooking evidence, therefore we have interpreted this deposit as a deliberately burned offering that was likely associated with the installation of the pappamonte block

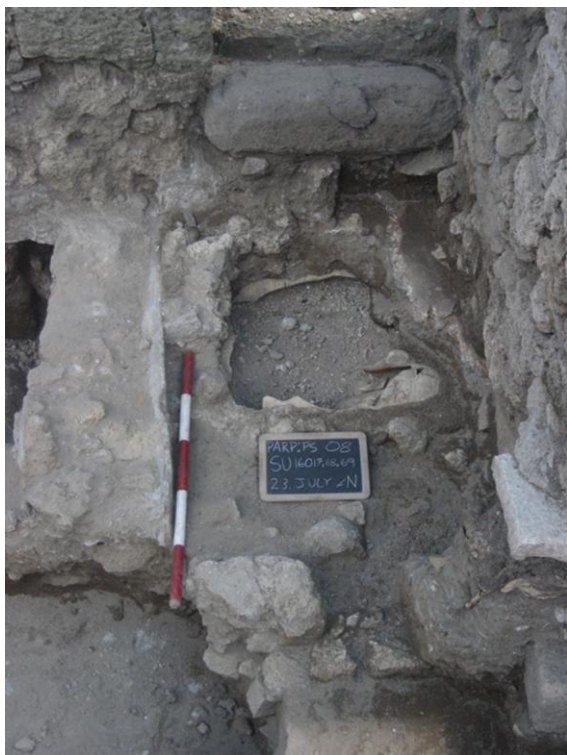
Fig 7. Several phases of the waste chute exposed, including the L shaped wall (left of the chute) that reoriented access to the chute from an area under the later walls and threshold.

A waste chute was installed early along the southern *opus incertum* wall (WF 108), which originally contained a wide doorway to Room 12 (fig. 7). This chute underwent several renovations during its operation. Slightly later than its installation, but still within the second half of the 2nd century BCE, a small L-shaped wall was placed around the chute seemingly to reorient its access from Room 15 to another space to the west (probably the precursor to the as yet unexcavated Room 16). Several roof-tiles were then laid against this new wall to create a small adjacent work surface. Next, the top of the waste chute was given a more substantial masonry capping of sarno stones set within a square of *opus signinum*, its weight supported by three buried amphorae. Finally, an amphora was placed upside-down near this feature to serve as an adjacent soak-away, but was later (but still within this phase) replaced by a more robust *opus signinum* basin of unknown purpose.

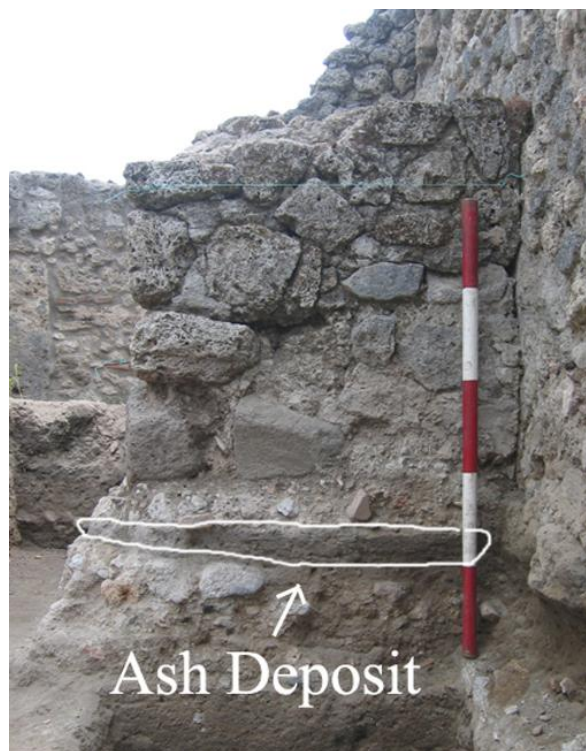
Fig 9. The ash deposit revealed in section below the western half of the later oven fixture.

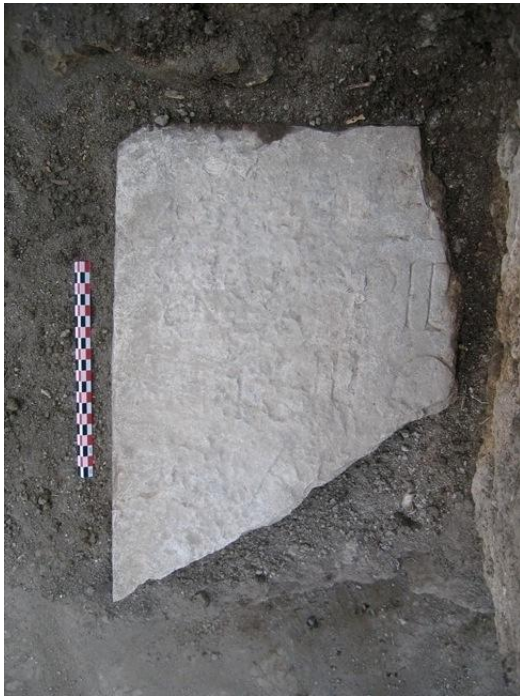
Fig 11. The worn fragment of a marble inscription that was reused in the threshold to Room 16.

A small oven and preparation surface was installed after this fire along the southern wall (WF 108) and the entire room was given a new raised floor (fig. 11). This necessitated the raising of the thresholds of the two communicating rooms to the west (Rooms 16-17). Several pieces of recycled marble were used as spolia in the reconfiguration of the threshold to Room 16, including one that had a very worn inscription on its surface, rubbed virtually smooth with foot traffic (fig. 12). We were not able to recognise more than a few letters because of the damage to this stone. The presence of somewhat abundant spolia is supportive of a post-62 CE date for the fire and subsequent remodelling of these spaces.

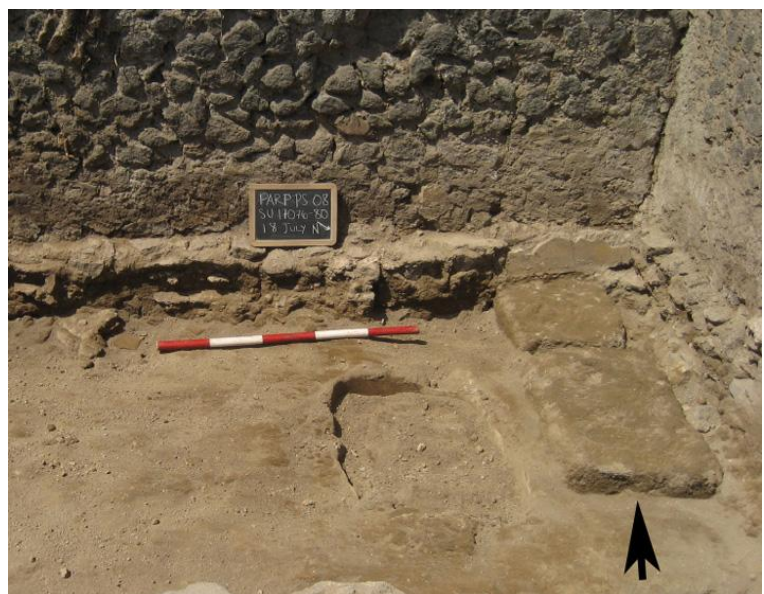
Fig 13. The two pappamonte foundation blocks in the north of Trench 17000.

As elsewhere in the southern half of the *insula*, the earliest structures here utilised pappamonte foundations dating to about the last half of the 4th century BCE (figs. 14-15). In Trench 17000 these consisted of two blocks of pappamonte constructed upon a yellow levelling fill above natural soil. Nothing else, however, was found in association with these foundations. Moreover, and as was the case for Trench 16000, these pappamonte foundations represent a phase of activity that was followed by a period of inactivity for close to two centuries¹².

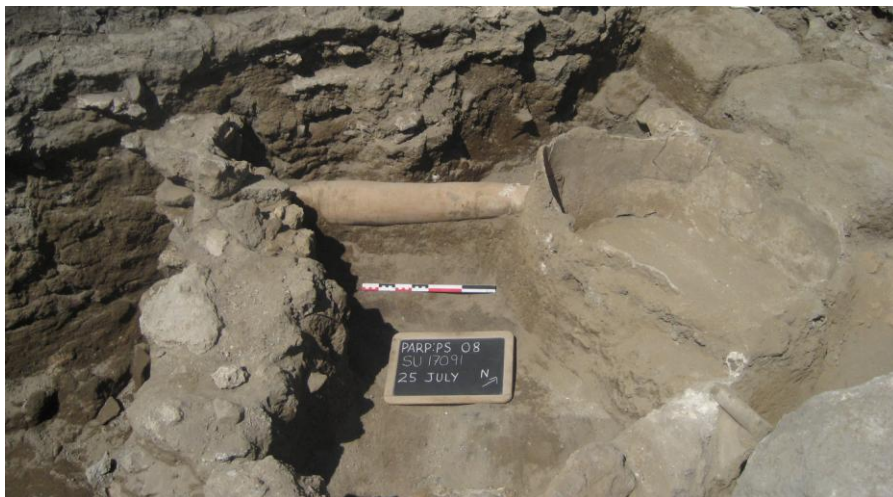
Fig 14. Oval basin with ceramic pipe leading beyond the later WF 208. More of the pappamonte blocks are exposed in the top-right of the picture.

The basin was drained by a terracotta pipe (via a perforated sheet of lead that acted as a strainer) that ran to the southwest beyond later architectural and trench limits (the later WF 208; fig. 16). It should be noted that the sheet of lead was affixed with iron nails and was therefore not designed to filter out impurities from entering the basin (since there would be no way to remove debris as it accumulated behind the

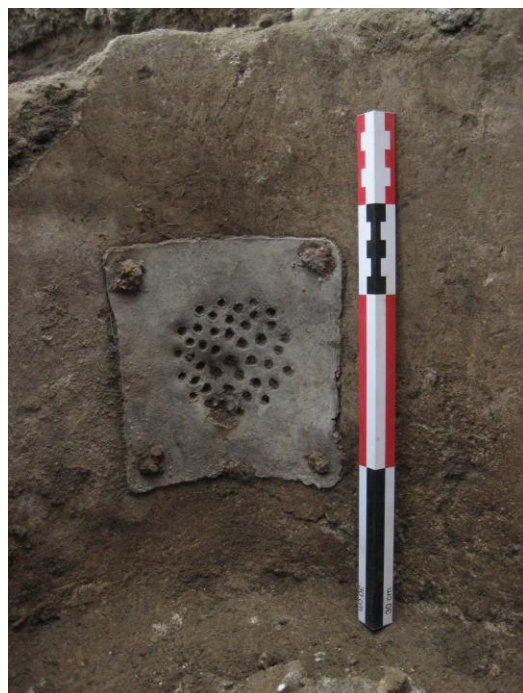
Fig 15. The perforated lead sheet covering the pipe opening inside the basin.

strainer). Instead the sheet kept whatever was held in the basin out of the terracotta pipe. A similar perforated lead sheet can be seen *in situ* to function in the same way in the gutter of a *peristyle* in I.9.11-12¹³.

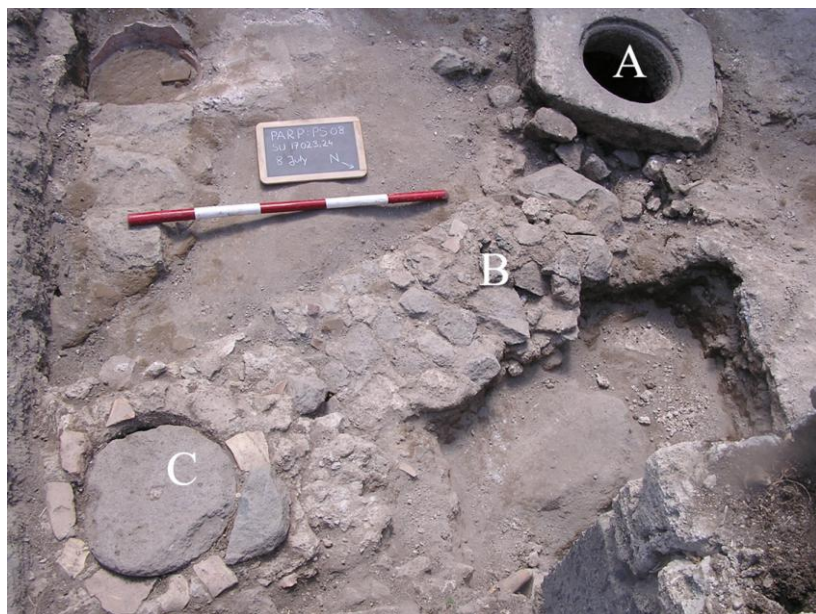
Fig. 17. Some of the installations of Phase 5, including: (A) the soak-away; (B) the drain; and (C) the capstone.

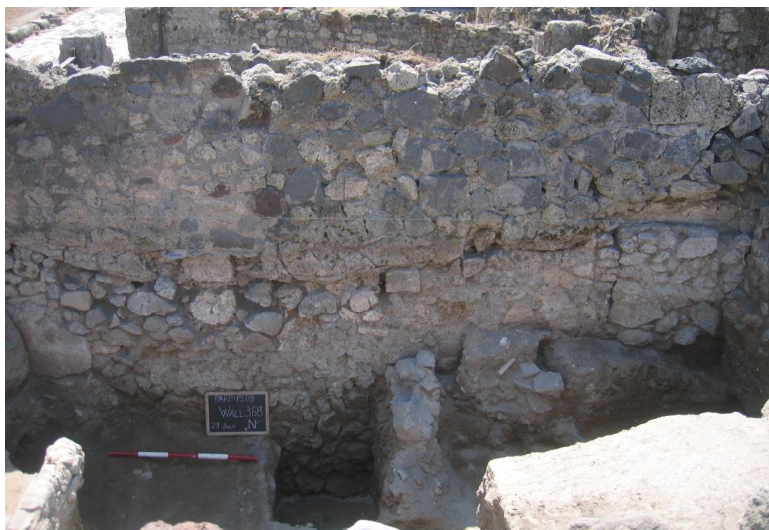
Fig. 19. The southern wall (WF 368) of Room 58 built directly onto the volcanic lava.

The construction of the southern wall (WF 368), which had foundations laid directly onto the volcanic lava that represents the so-called 'bedrock' for this area of Pompeii (figs 20 and 30), represents the earliest activity in this trench. This wall was actually built as the northern boundary for the southern neighbour at property VIII.7.9-11 (for Room 48), for all walls north of its construction within this trench and the property (entrance 12) only appear in later phases. This fact alone has important and broad implications for the overall development of the *insula* because it demonstrates that the property at 9-11 was built prior to the property at entrance 12. As a consequence, a paucity of diagnostic objects within Trench 18000 could help date this phase; this earliest phase of construction for property 9-11 has otherwise – and still tentatively without further and stronger evidence – been attributed to at least the mid 2nd century BCE based on stratified relationships to datable contexts elsewhere¹⁷.

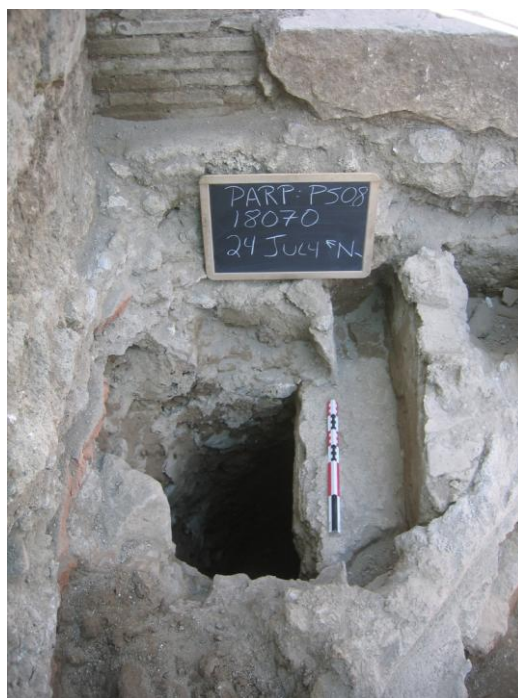
Fig. 20. The opening to the waste chute in Trench 18000.

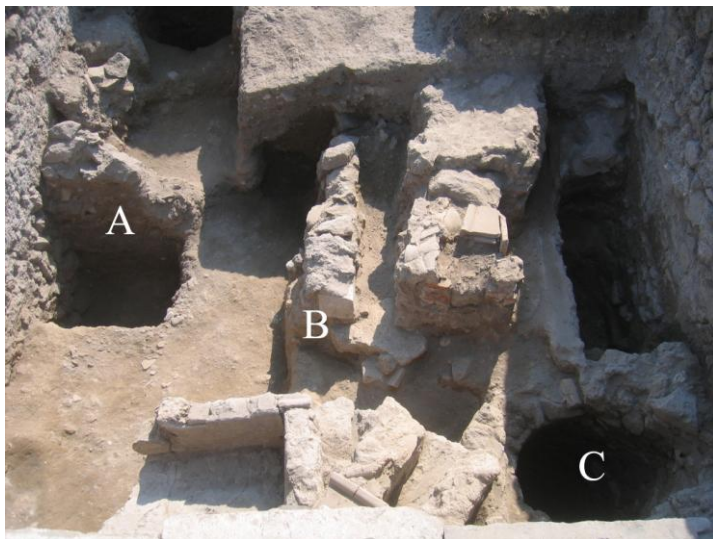
Fig. 21. The small room in the southeast corner of the trench was formed by the addition of a north-south wall (A) and east-west wall (B) (looking west). Note the opening to the waste chute (C).

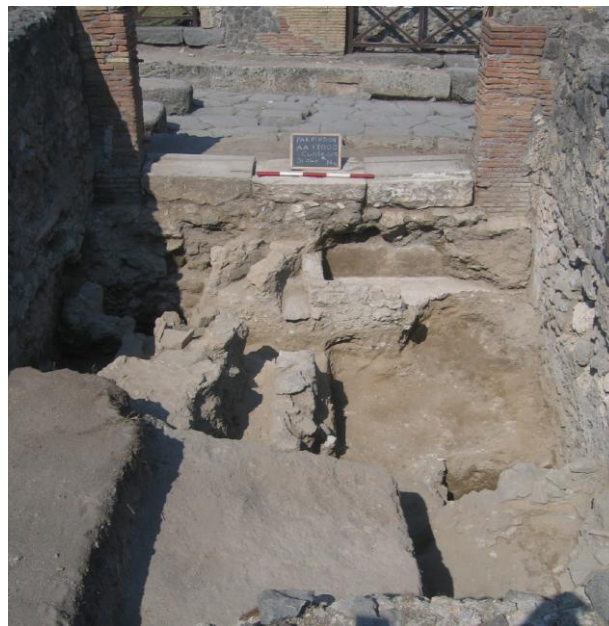
Fig. 22. The location of the tank within and under the (later) threshold to Room 58 (looking east toward the *via Stabiana*).

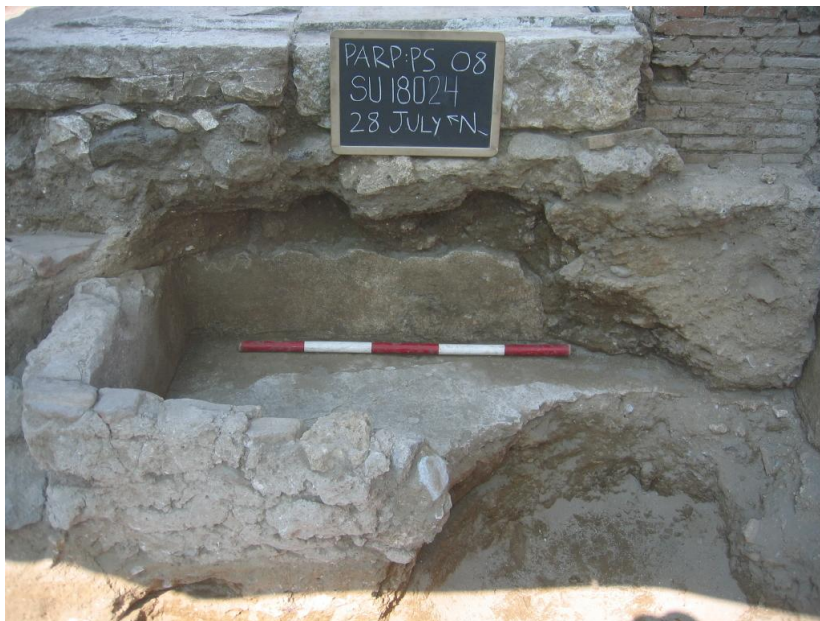
Fig. 23. Close-up of the tank, its southern extent mostly destroyed by later building activity.

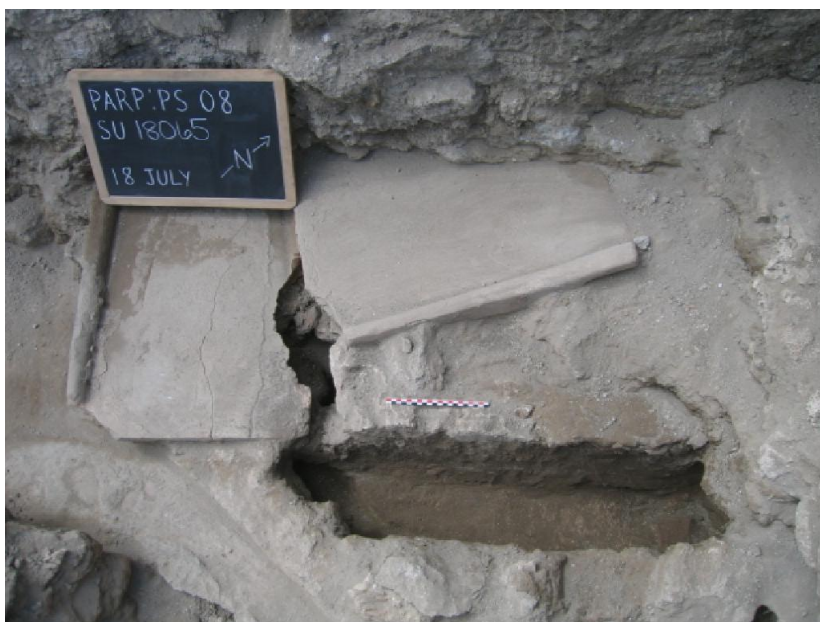
Fig. 24. The two roof-tiles cap the waste chute from the previous phases. The new drain passes over the chute toward the *via Stabiana*, right of the photograph.

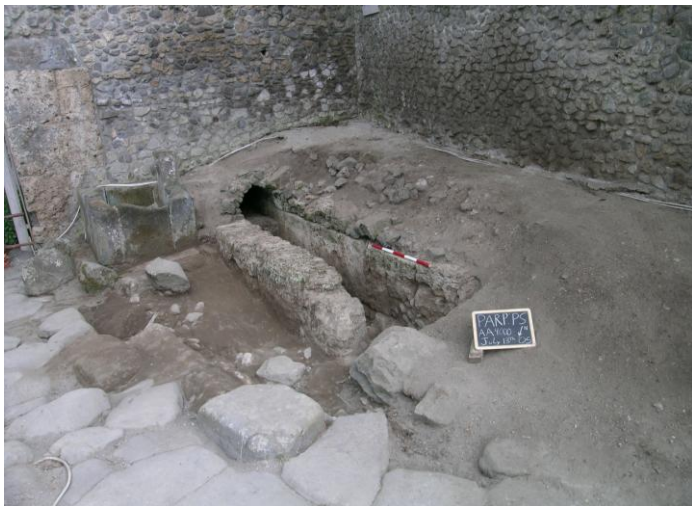
Fig. 25. The city drain at the southern extent of the *via Stabiana*, passing behind the *Porta Stabia* fountain and through the gate itself.

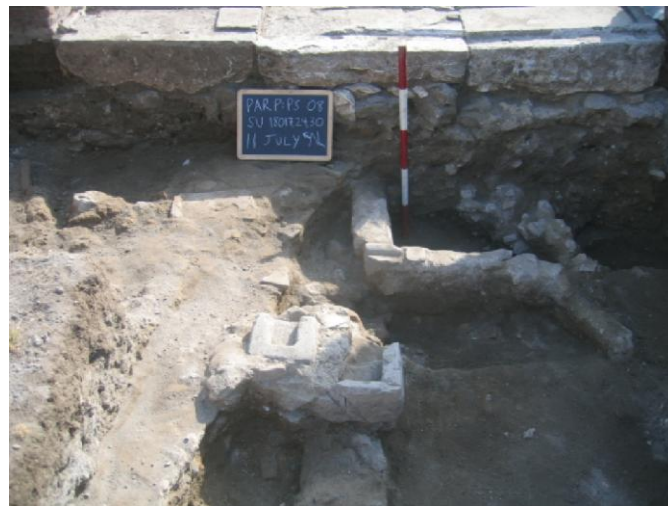
Fig. 26. The two *repagula* (door-stops) of Phases 4 and 5. The one on the right is from Phase 4, the other Phase 5. Note their location behind the middle threshold block.

caused certain streets to be raised and re-surfaced to handle the extra torrents of waste-water, which in response caused the floor-levels of a number of street-side rooms to be raised to avoid flooding, caused now-obsolete waste chutes to be capped, and caused new drains to be laid to run toward, and thus be flushed by, the sharply increased volumes of water on the street. The impact of these infrastructural developments on the street itself, as well as the *Porta Stabia*, is seen in the creation of a new drain that was installed behind the *Porta Stabia* fountain to redirect the torrents from gushing through the gate (fig. 26)¹⁹.

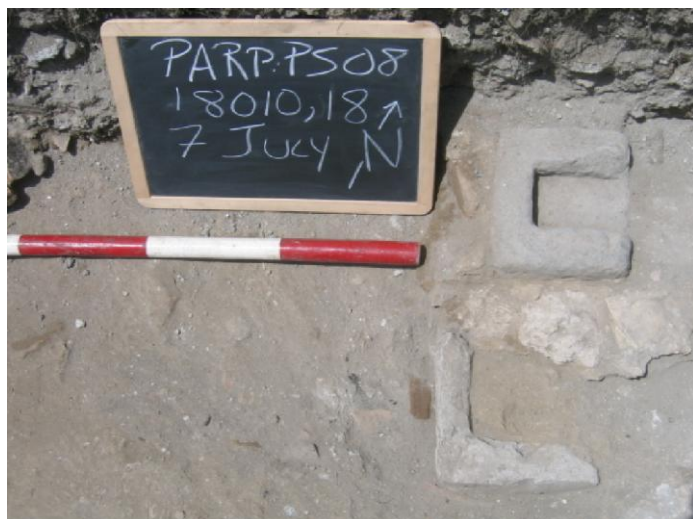
Fig. 27. Close-up of the two *repagula*. The one below is from Phase 4, the other Phase 5.

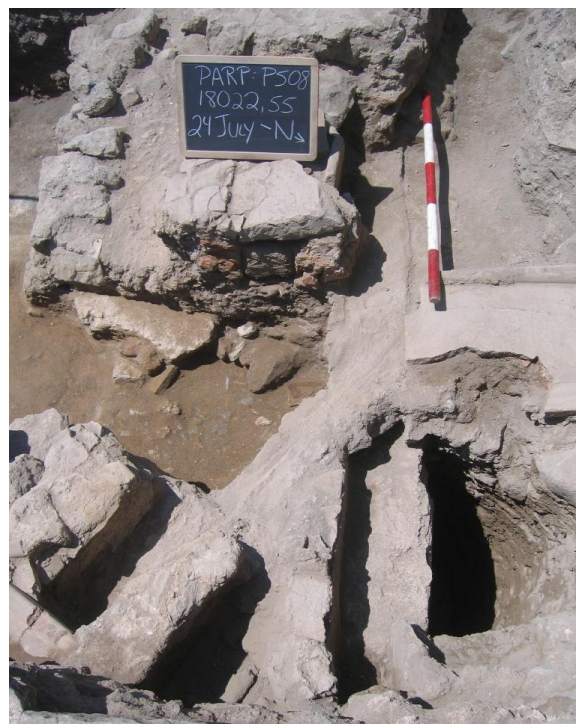
Fig. 28. The large Phase 5 drain, partly removed to reveal section (beneath chalk-board).

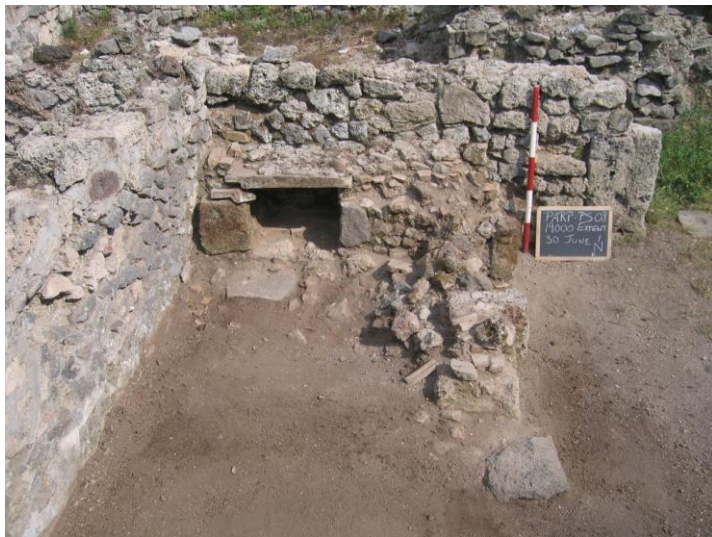
Fig. 31. The cooking structure in Trench 19000.

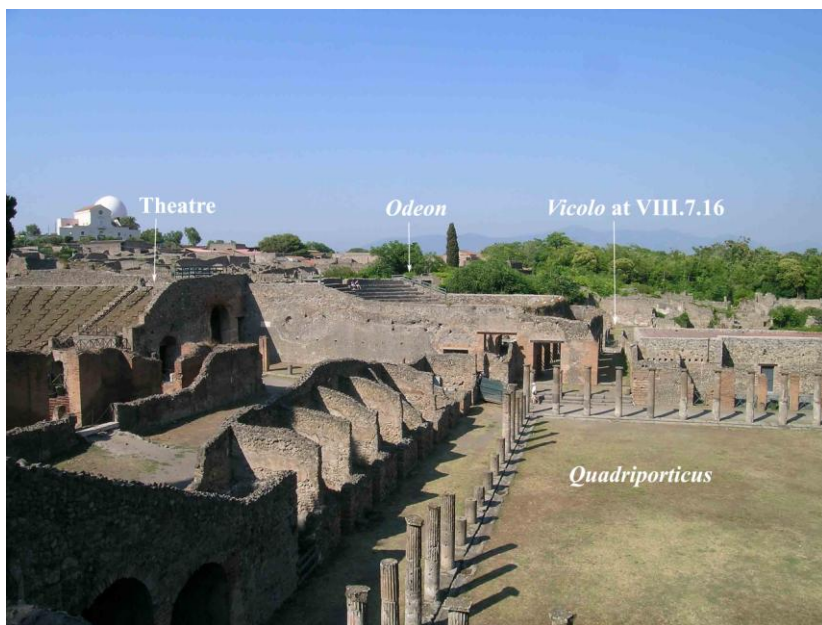
Fig. 33. The *Quadriporticus* with its entrance from the *vicolo* of VIII.7.16, looking east.

Trench 20000 was located within the *vicolo* of the *Odeon* to abut that structure and the northern limit – as defined in 79 CE – of our *insula* (fig. 33)²⁹. This space is usually labelled as VIII.7.16 and is considered to be the main entrance to the *Quadriporticus* (fig. 34). We excavated this trench with the hope of determining the extent of some earlier structures uncovered just to the south in Trench 8000 during our 2006 season; one of the early-phased walls of that trench projected further north than the later delineation of the *insula*, so it was for this wall, and so its arrangement of space, that we hoped to uncover and relate to the construction of the *Odeon* itself³⁰.

It was only after this drain was in place that the northern wall (WF 464) of our *insula* was constructed (figs 33 and 37). Whether this construction occurred within this actual phase, or as part of a following (and separate) one, is uncertain, but the wall was at least built against the drainage feature and both events can be attributed to the early 1st century BCE. This was an important development in this area as the construction of this drain and wall now defined the northern limit of the *insula* through to 79 CE. This primary construction of the northern boundary to the *insula* did not extend entirely westward to the *Quadriporticus*, however, as it appears today. Instead, it extended from the street-front only so far as the now-buried N-S wall from the earlier phase. From this point to the eastern limit of the eastern suite of rooms of the *Quadriporticus* appears to have been an open space – some kind of yard that was open to the *vicolo*.

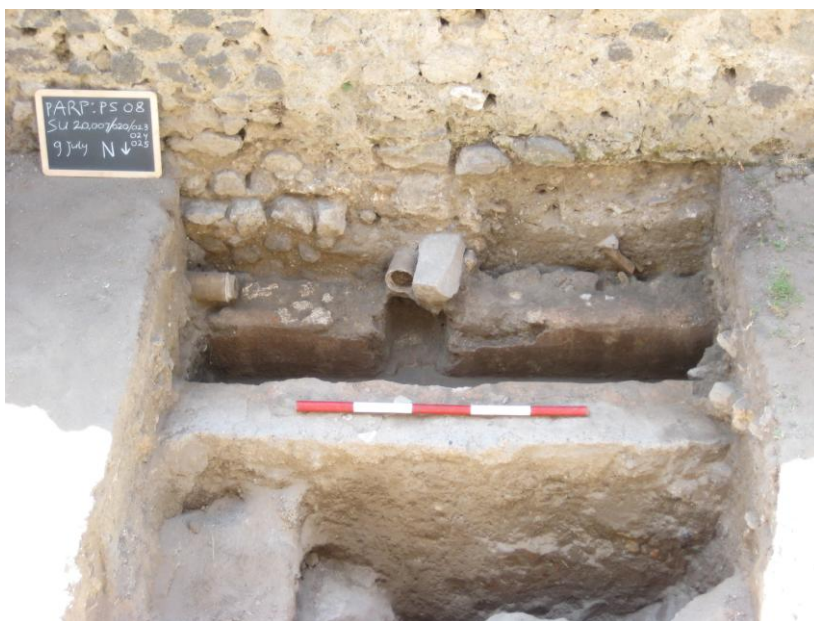
Fig. 34. The open drainage channel just below WF 464.

The cutting and dismantlement of the earlier wall served the construction of a large and open drainage channel (figs 35-36) that ran on a 1-2 degree grade from west to east across the southern limit of the trench, likely from the *Quadriporticus* to an as yet unidentified outlet on the *via Stabiana* (a geophysical survey of this *vicolo*, sche-

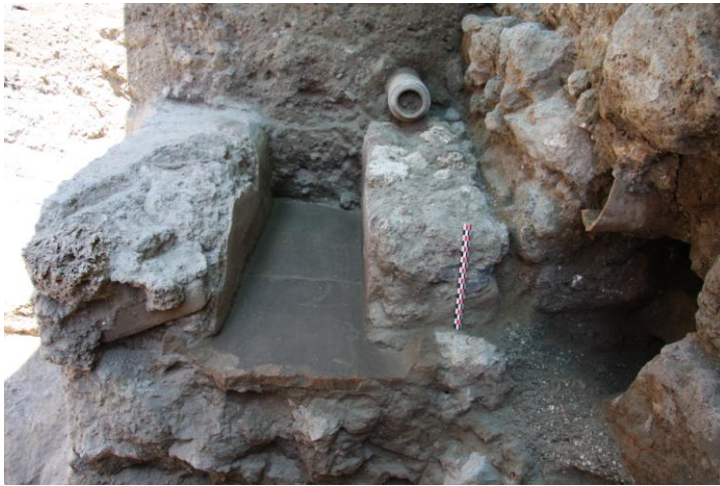
Fig. 35. The drainage channel in section, looking east.

ded for March of 2009, should reveal more of its course). The drain was built of mortared masonry and brick, with large (approx. 50cm x 50cm) roof-tiles used for the bedding of the channel (fig. 36). This channel was 30 cm deep as well as wide, and lined with a sturdy hydraulic plaster.

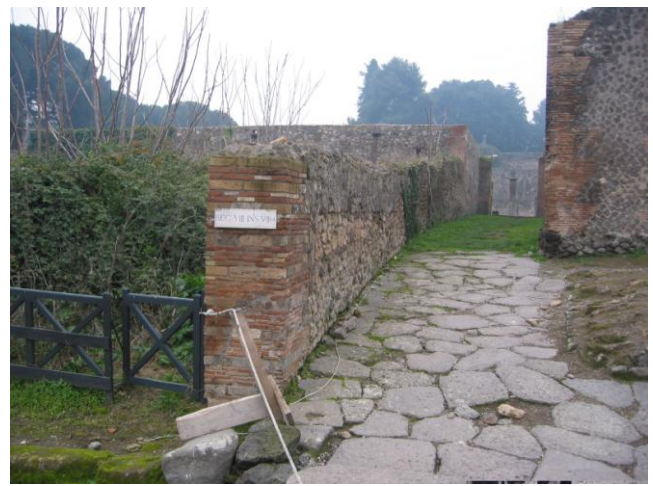
Fig. 36. View of the northern limit of VIII.7.1-15 and the vicolo of VIII.7.16. This vicolo was the main entrance from the via Stabiana to the *Quadriporticus*. The Odeon is at right.

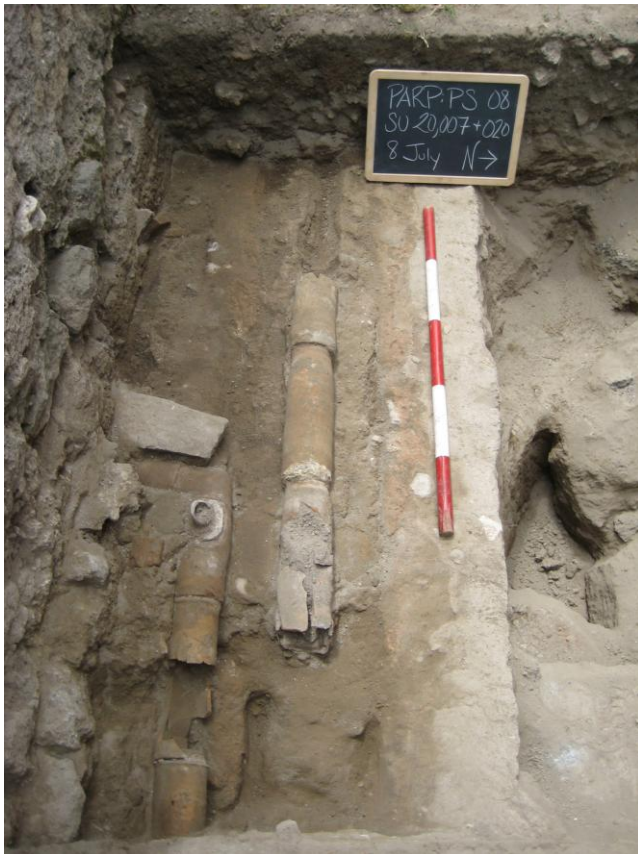
Fig. 38. The two courses of terracotta pipes built within the earlier drainage channel (that on the left came from within WF 464).

pe was approx. 15cm diam. X 50cm length (fig. 39). One course followed the original east-west course of the channel – its origin and destination as yet unknown. The other was built within the new extension of the wall, thus vertically from an upper floor or roof, but upon reaching ground level it turned eastward along the same drainage channel, again toward an as yet undiscovered destination. The construction and arrangement of each pipe is of some interest. The northern pipe that originated from the west terminated precisely where the pipe from the wall now entered. Each course of terracotta pipe was joined here by a lead fixture (each of which has since been removed by the earliest excavators, it seems) that was inserted into each pipe system to enable the contents of the northern course to now run through the southern (fig. 40). This bonding of the pipes, as well as their similar appearance and construction (each of the terracotta pipes was joined to the next by a lead bonding), raises certain questions about their commission: how was this element of hydraulic infrastructure organised, with the northern pipe likely originating from a public space/construction, while the similarly constructed southern course was of a seemingly private construction?

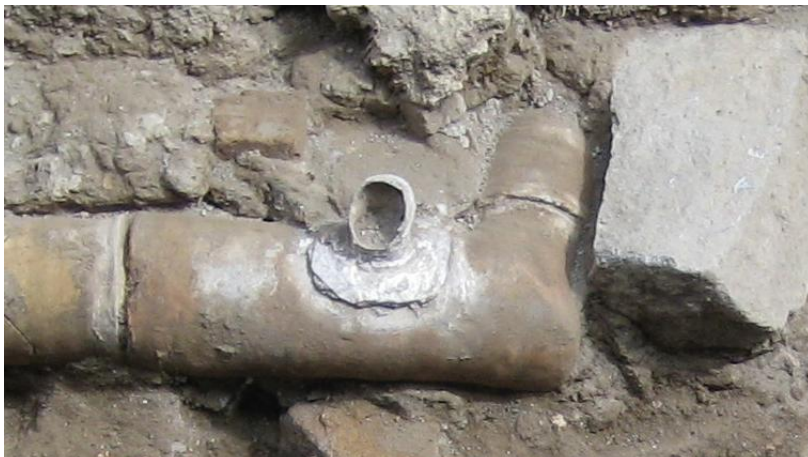
Fig. 39. The lead joint within the terracotta pipe that came from WF 464.

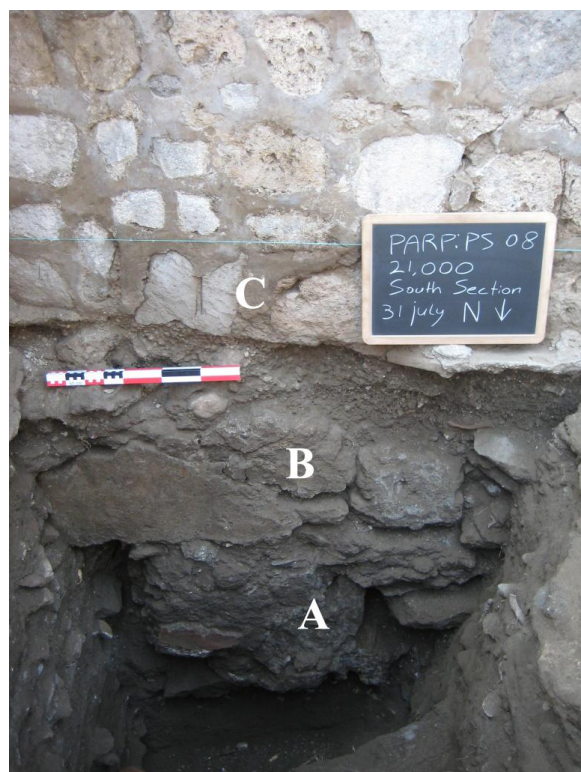
Fig. 41. The three phases of southernmost wall in Trench 21000, being: (A) the earliest, plastered red; (B) the second, plastered yellow; and (C) the latest (WF 157), which is here almost completely reconstructed in modern times.

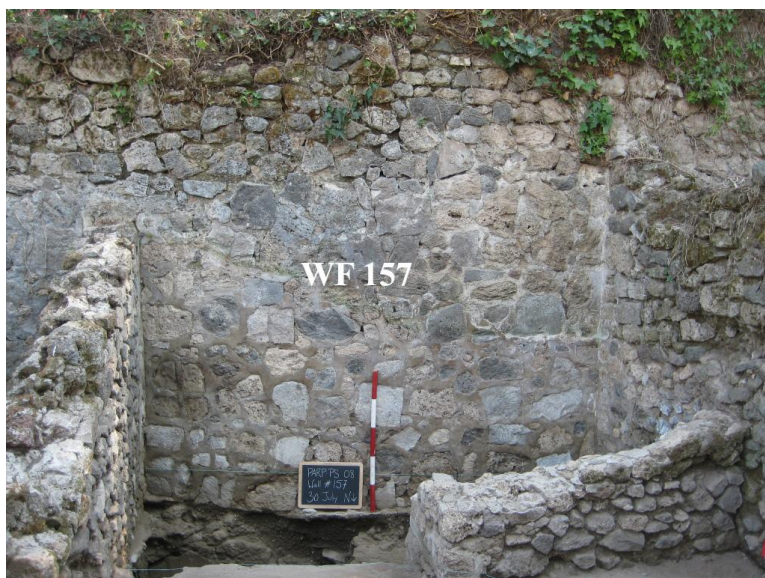
Fig. 42. WF 157, the southernmost structural limit to the *insula*.

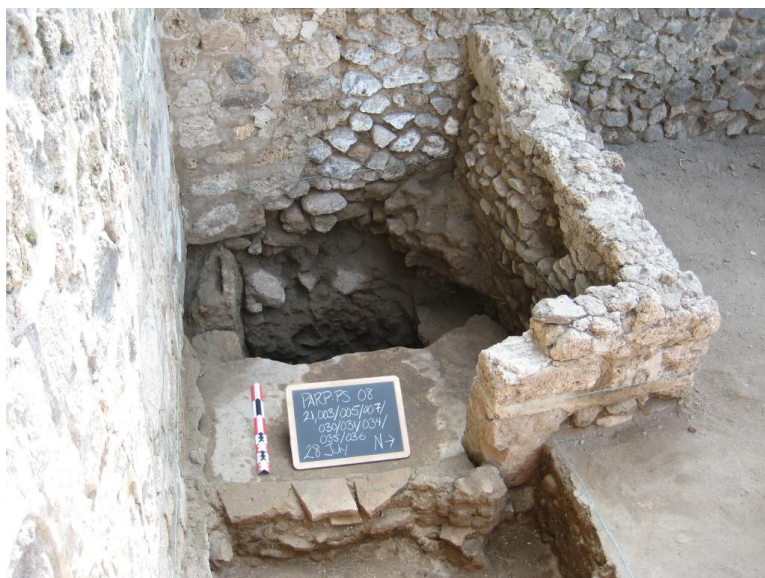
Fig. 43. The toilet in the western end of Room 27.
