Daniel M. Millette

## **Monuments of Spectacle as Places of Cultural Interaction: Initiating Explorations at the Theatre of Uthina (Oudhna), Tunisia**

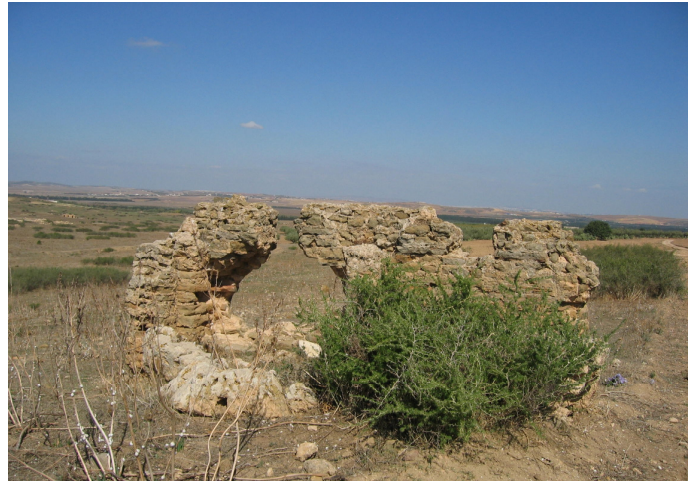
Fig. 1 - Typical Architectural Element.

As one leaves the centre of the settlement's urban plan, and along its outskirts, a series of architectural elements pierce the ground (fig. 1). Where the theatre would have stood, arches of two types appear at various levels, some assembled from smaller *moëllons* and other made of large blocs, installed at levels obviously corresponding to rises in the ground and by observation, to the various levels of the *cavea* (figs. 2-3). Architectonic blocs, or support consoles, made of several large blocs and measuring approximately 3 x 3 m, appear to have been constructed as the main supporting elements for the *cavea* (fig. 4). As with the arches, the support consoles are installed along concentric rings, presumably following the *cavea*'s curvature. In addition to the arches and consoles piercing the ground, one significant wall section still stands, as well as prominent flat surfaces just centimeters below the sandy soil (fig. 5). The whole constitutes a set of building components that should eventually render enough indices for a full hypothetical reconstruction of the monument.

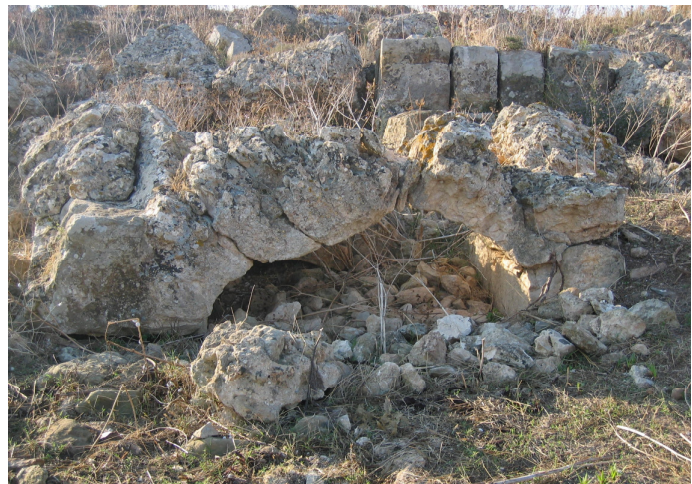
Fig. 2 - Typical Stone Arch.

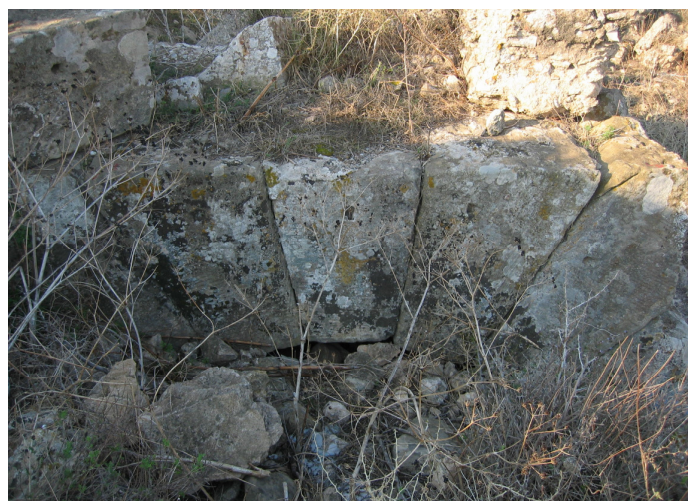
Fig. 3 - Typical Bloc Arch.

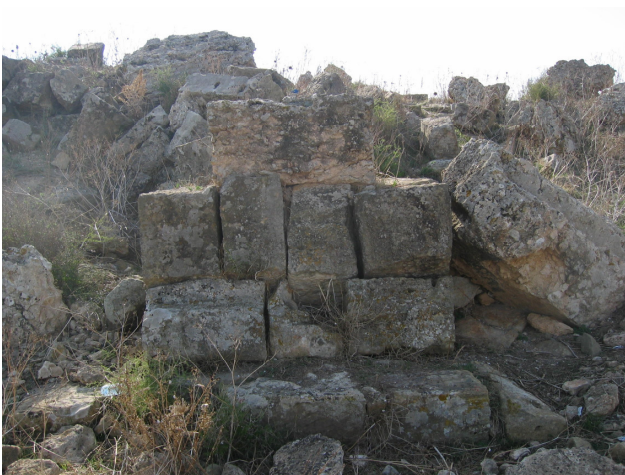
Fig. 4 - Architectonic Support Bloc.

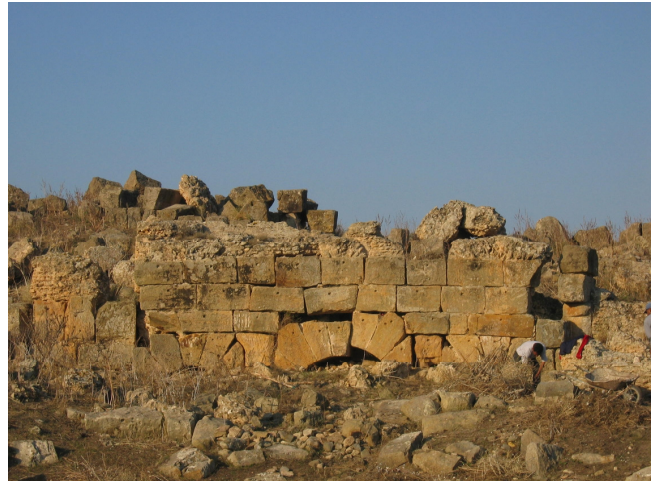
Fig. 5 - Cavea Wall Section.

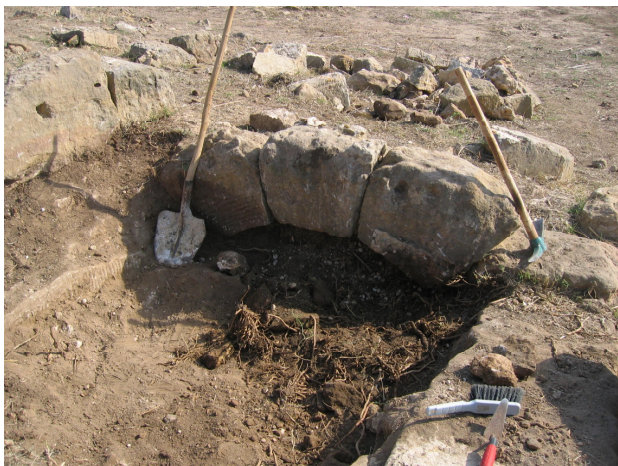
Fig. 6 - Archway, *Cavea* Access.

The latter archway is situated above a 1,8 m passageway and slopes downwards towards the center of the *cavea* (fig. 6). The downwards slope is approximately 25 degrees. The same passageway is bordered by

large, smoothly chiseled blocs, all of some 1,5 m in length. Relatively close to the archway are similar blocs, in place. Their precise role in the architectonic arrangement of the passageway is not clear.

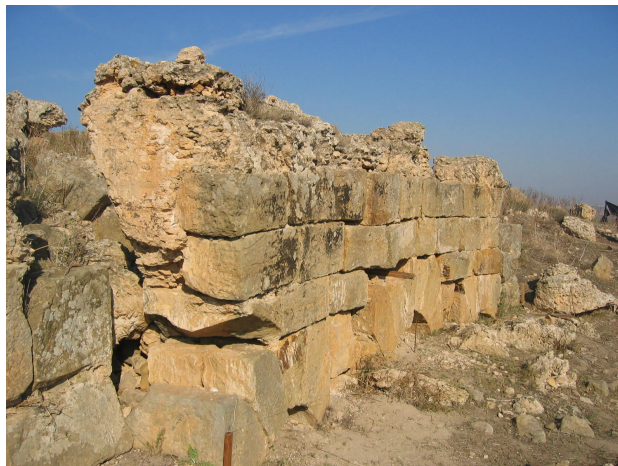
Fig. 7 - *Cavea* Wall Section – Angled View.

Without doubt, the *media cavea* presents the most evocative pre-excitation structural element. This wall section is well preserved. The wall section reveals a host of design and construction details. The ensemble constitutes a portion of a wall constructed of large blocs, arranged in a curvilinear pattern within an arc of 19 degrees on a segment of 26,2 m. It is delimited by two massive substructure blocs. The wall segment extends to 3,3 m above ground, where three bays can be assessed (fig. 7). All of the construction blocs, as in most extant theatre segments, are well chiseled. The central dominant bay is framed by two cor-

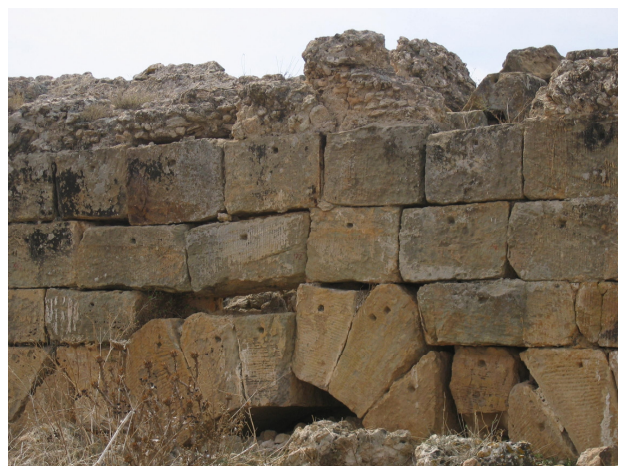
Fig. 8 - *Cavea* Wall Section – Upper Section in *Opus Caementicium*.

respondingly symmetric, slightly less monumental bays. The upper level of the wall comprises arcs in *opus caementicium* (fig. 8), each with traces that show an orientation towards the centre of the *cavea*, suggesting a construction detail that is markedly different from the lower bloc section. The section above the central dominant arch is level, while the sections above the two symmetrical arches radiate outwards and towards the central *cavea*. Interestingly, the rear section of the same wall segment also comprises a substantial massif in *opus caementicium* (fig. 9). It sits upon a lower archway, perpendicular to the main wall segment. Clearing of the debris around the massif revealed a probable circulation arcade behind the main wall segment; all substructure blocs along this level appear to include this feature.

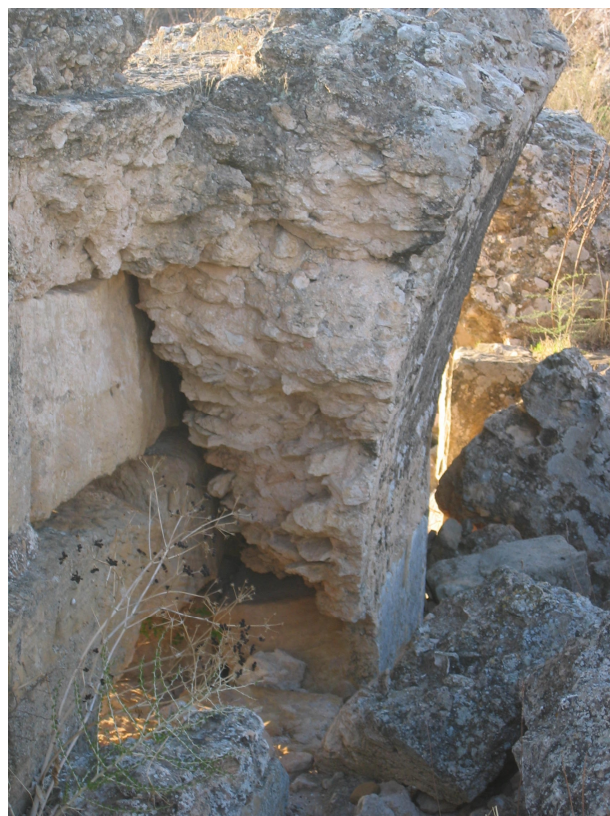
Fig. 9 - *Cavea* Wall Section – Rear Segment.

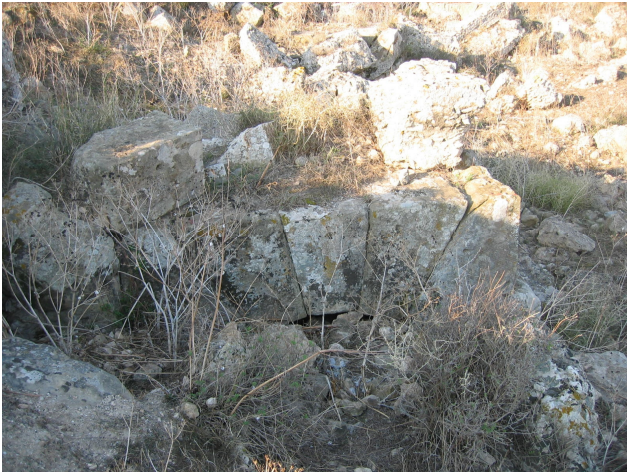
Fig. 10 - *Summa Cavea* - Bloc Arch.

Along the highest extant level of the *cavea*, and roughly along the same axial transect, a further feature is located at 35 m from the theatre's hypothetical center (fig. 10). While not analyzed in detail, the arrangement suggests a passageway leading to circulation corridors within the upper *cavea*. The main element of the same ensemble, an arch comprising five main blocs, measures 1,8 m in diameter. The arrangement is complex, with various

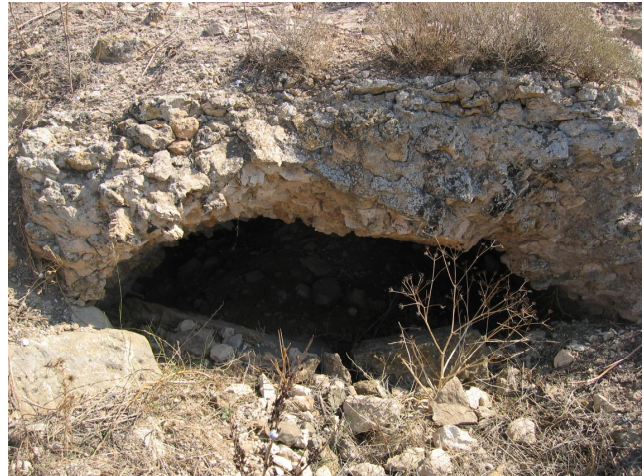
Fig. 11 - *Rear Cavea* – Stone Archway Opening.

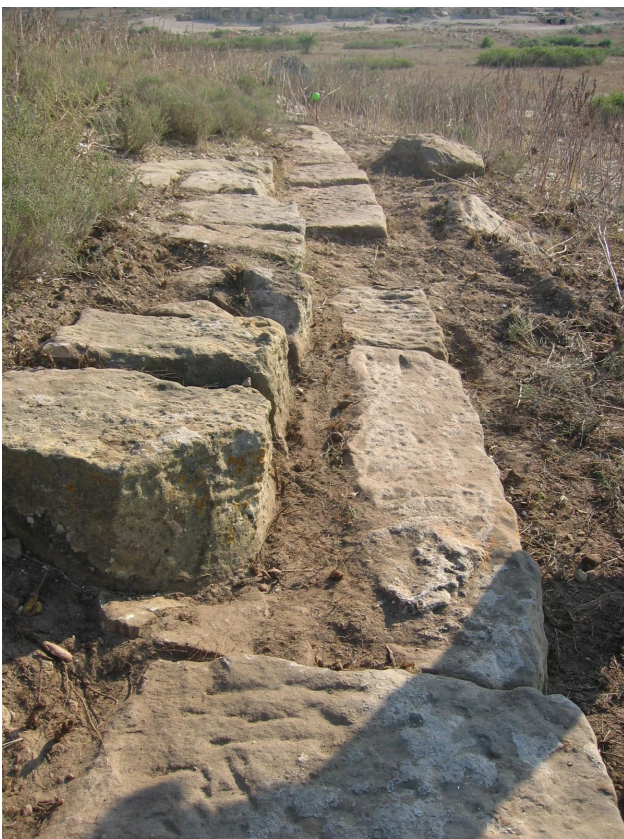
Fig. 12 - *Rear Cavea* – Curvilinear Wall Base.

Further away from the center of the *cavea* and still behind the latter feature is another clue to the theatre's circulation network. A passageway, partially collapsed, is observable from above. Further towards the outer reaches of the monument, along the same radiant and oriented towards the monument's center, an archway provides an entrance to the inner area from the exterior via the corridor observable from the collapsed portion (fig. 11). The corridor is made of small blocs, is vaulted and covered in mortar. Yet further behind the *cavea*, a significant surface of large, flat blocs was uncovered (fig. 12). At least two courses of this

wall remain; it appears to follow the curvature of the *cavea*. The wall may have been meant as a structural load bearing component that would have been required to spread the weight of the exterior face of the *cavea*.

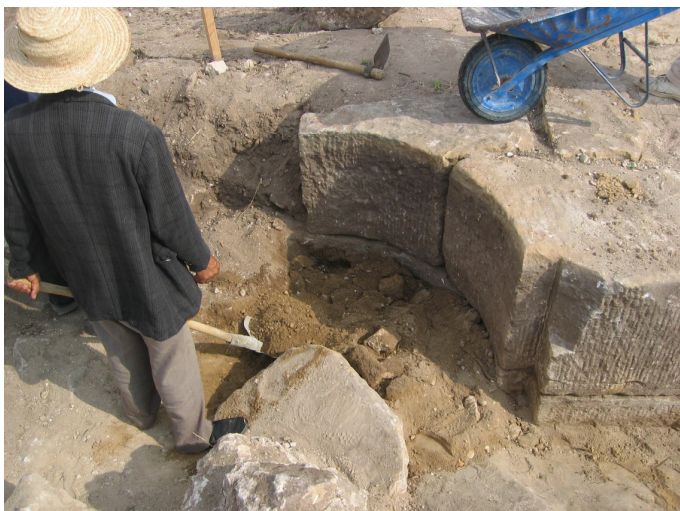
Fig. 13 - *Scaenae* Building – *Basilicae* Feature.

Two large consoles delimit what would have been a wide opening (7,0 m) at the rear of the *scaenae* wall, measuring approximately 42 m. Surprisingly, these are not symmetrical in terms of the theatre's hypothetical axis. Within each of these consoles, or as part of them, are the *basilicae*. The north-western sector of the building was excavated to a depth of approximately 1,5 m, reaching the initial built surface which is intact. The most important find in this sector is what can best be described as a semi-circular niche built out of large blocs cut to accommodate the cylindrical arrangement (fig. 13). Its diameter is 1,6 m, and three courses survive. The blocs are adapted to what may have been a narrow passageway leading from the outer to the inner *scaenae* building. A cornice fragment was uncovered within this area. Excavations in the corresponding north east corner of the *scaenae* building did not confirm a similar architectural feature; the section clearly has been robbed of its blocs and it is possible that the whole was removed.

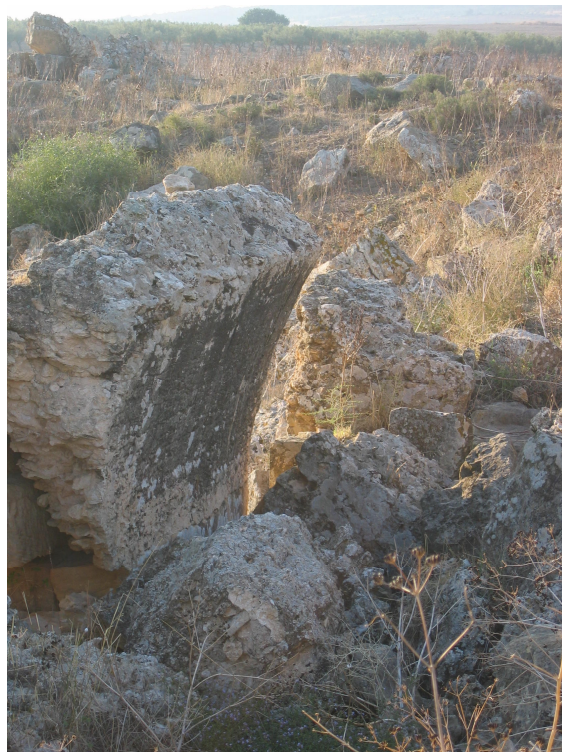
Fig. 14 - Extant wall surface, rear central arches.

Related to the same areas, there are examples of the type of construction used in what appears to be the entire theatre. Very large blocs making up the structural components, and quite small *moëllons* used to fill the gaps between the structural elements and the desired wall surfaces or curvatures, as well as some secondary archways. This shows up along all extant wall surfaces and we can clearly observe the technique behind the main, central arches (fig. 14).
