# BOLLETTINO DI ARCHEOLOGIA ON LINE

## MONITORING METHODS AS A PREVENTATIVE MEASURE. THE EXAMPLE OF THE *CAPITOLIUM* IN OSTIA ANTICA

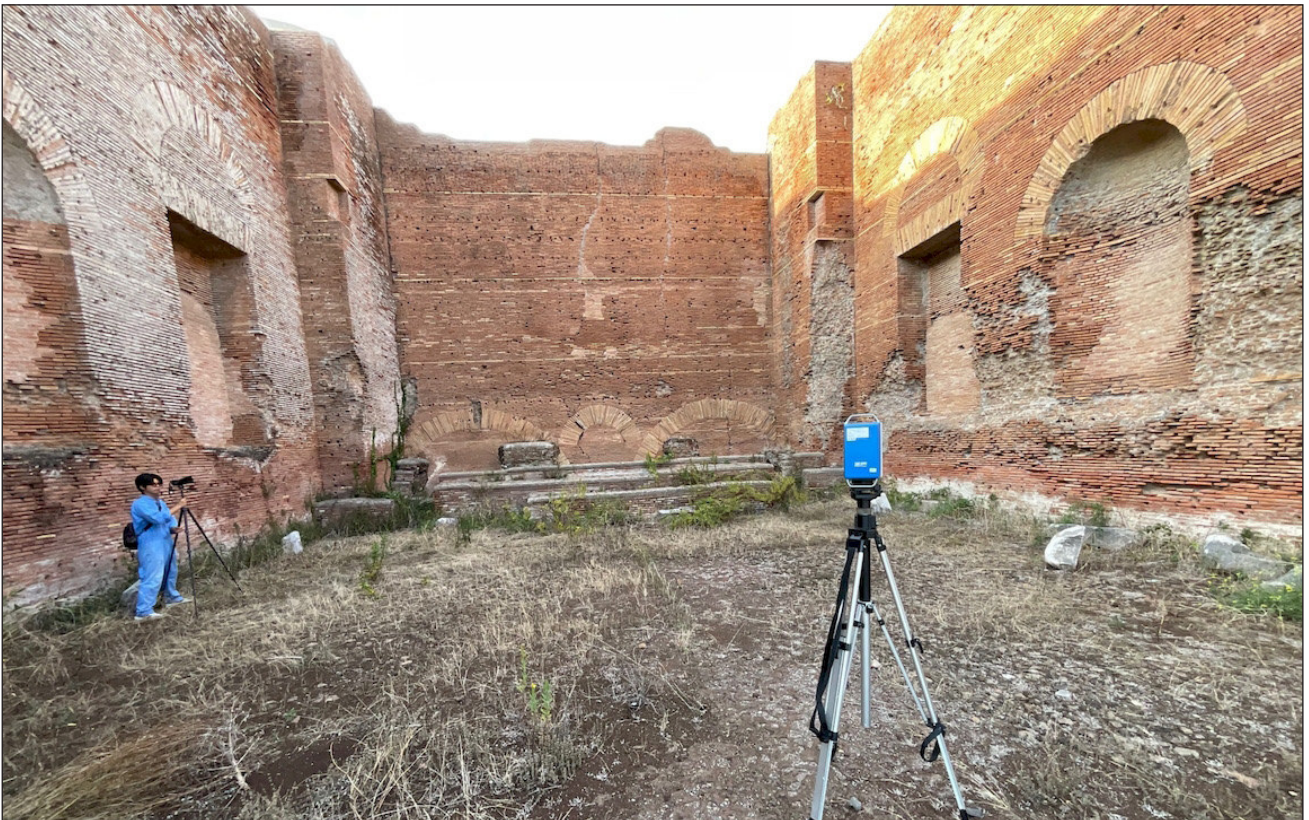
2. A. *CAPITOLIUM* (2024); B. LASER SCANNER SURVEY PHASE FROM THE *CAPITOLIUM* PODIUM (2024) (photo by L. Pecchioli)

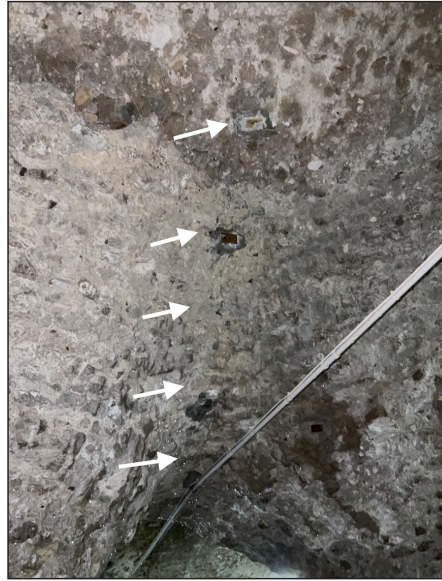
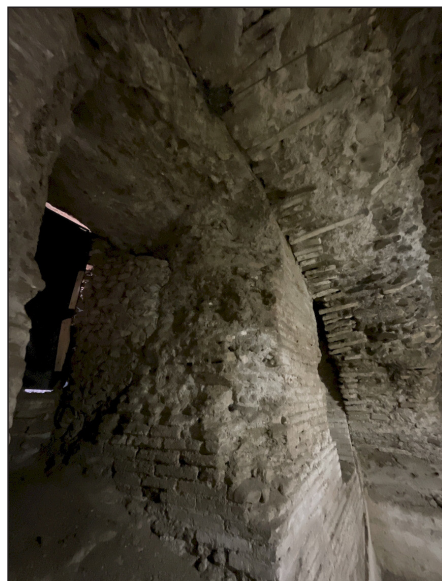
3. A. DETAIL OF THE INSERTION OF WOODEN WEDGES IN A CRACK IN THE INTRADOS OF THE VAULT; B. INTERVENTION SCHEME FOR REINFORCEMENT TO RESTORE THE PRESSURE CURVE WITHIN THE MIDDLE THIRD: LOWERING OF THE PRESSURE CURVE AND AN INCREASE IN THRUST; C. EXAMPLE OF STRUCTURAL REINFORCEMENT IN MASONRY ALONG A PERIMETER WALL (elaboration by L. Pecchioli)

Through the detailed survey, a longitudinal section reveals subsidence phenomena in the podium due to foundation failures, notably in each room, which contributes to justifying the various and numerous reinforcement devices<sup>19</sup> (*fig. 3, A-B-C*).

Various interventions include inserting wooden wedges at different heights to adjust the original curvature and counter structural deformation. One of the most common historical and modern techniques is to insert large reinforcing brick sub-arches to stabilize the deformed barrel vaults (*fig. 3, B*). Following initial assessments, the vault's depression indicates the entire ceiling's instability due to shutter settlement<sup>21</sup>. This approach, resembling a maintenance practice, includes placing wooden wedges into cracks in the vaults' intrados and sealing them with cement, exemplifying modern carpentry techniques. Such a choice represents a temporary measure at construction sites, often used by ancient builders' restoration and repair techniques instead of demolition. The aim is to restore the pressure curve within the middle third by increasing thrust and enhancing structural integrity. These interventions stabilise specific sections and offer cost-effective and efficient carpentry solutions dating back to ancient times, the Middle Ages, and the present day.

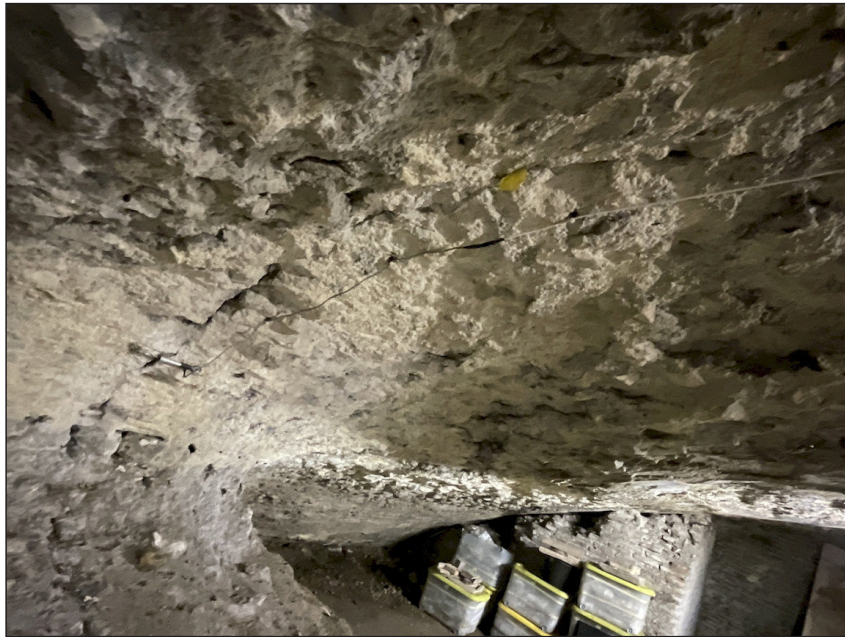
4. CRACK UNDER THE STAIRS IN THE PODIUM (photo by L. Pecchioli)

Even externally vertical fractures at the top corners of walls indicate weak structural connections, leading to external rotation and detachment at the summit. Specifically, a significant crack traverses rooms with barrel vaults, likely originating from an ancient collapse under the Podium staircase, which probably immediately required the insertion of three supporting pillars. The crack extends through the entire thickness of the barrel-vaulted rooms, constructed using *Opus Caementicium* (*fig. 4*). It exhibits compression damage near the stairs. It is located at the peak of the inner arch supporting the staircase.<sup>20</sup>

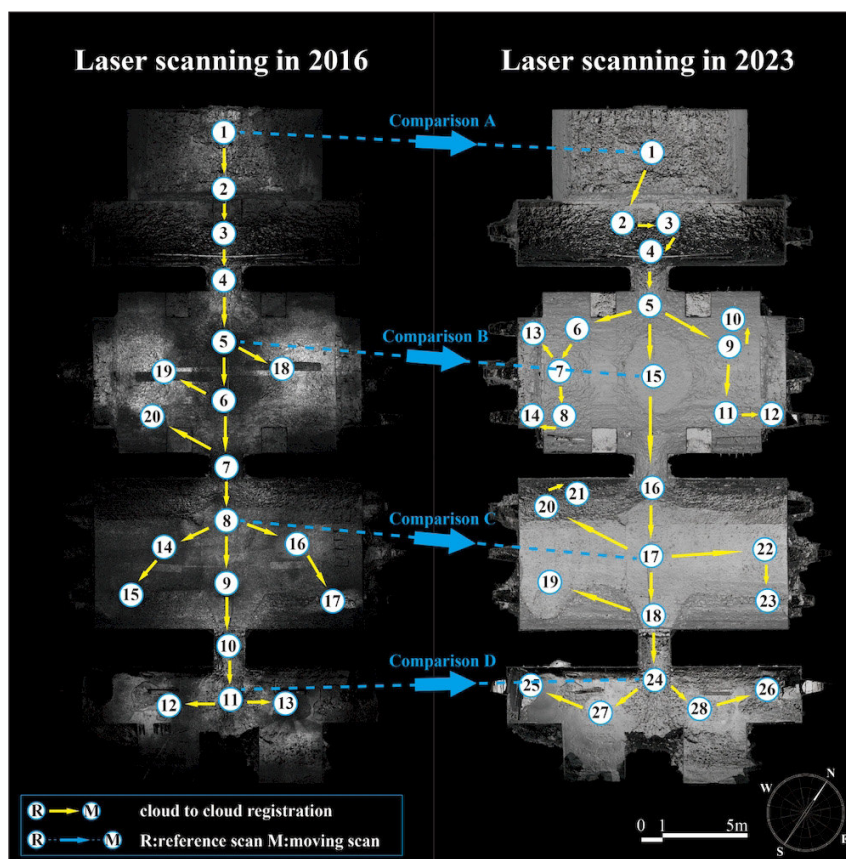
5. SCANNER PLACEMENT AND PAIRINGS FOR THE POINT CLOUD ALIGEMENT (elaboration by T. Ogawa)

Due to the westward change of the Tiber Delta over time, the ancient harbour now lies within the coastal plain, buried beneath 20 to 40 meters of alluvial sediments. Measurement monitoring was necessary considering the environmental conditions and the obvious structural deformations. Field surveys using laser scanning were conducted<sup>22</sup> in 2016 and 2023 (*fig. 5*).

To compare the results from point cloud data in this period, a point cloud from a similar location was selected for each year and aligned (comparison A in *figs. 5 and 6*). During the calculation using the least squares method, the relative positional coordinates of the overall point cloud data of the platform's interior remained unchanged. The comparison of 2016 and 2023 revealed displacements of about 2,0 cm in some areas, indicating that the data from both years did not perfectly match. Other pairs of reference and moving scans were selected from four rooms to eliminate the possibility that the 2,0 cm gap could have arisen from alignment errors. Reviewing the histograms for each pair, the results of comparison B, which showed the smallest displacement, are likely the most reliable.

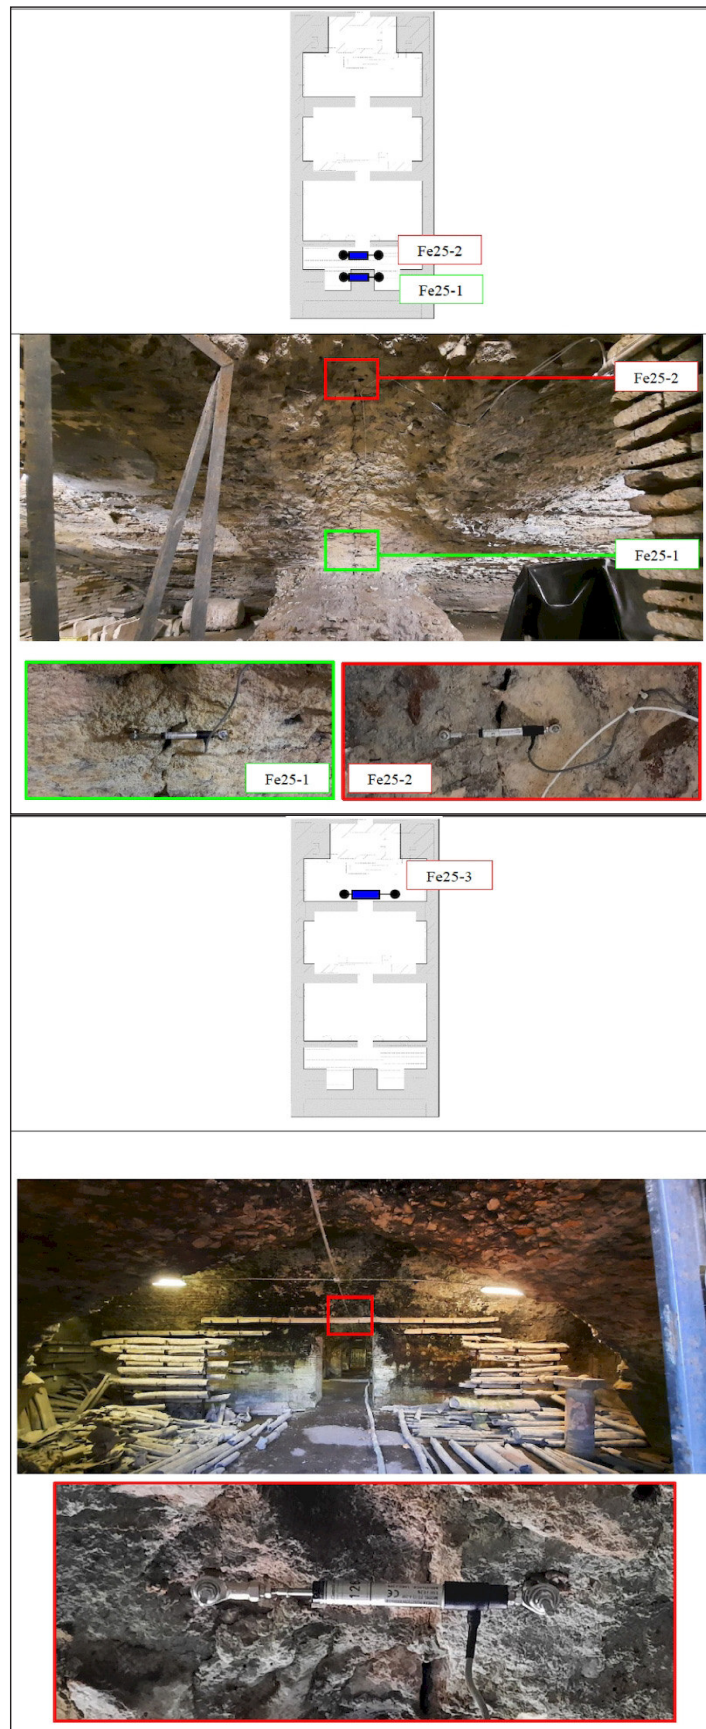
11. A. PLACEMENT OF LESION MONITORING SENSORS UNDER THE STAIRCASE; B. DETAIL ABOUT THE SENSOR TYPOLOGY (elaboration by C. Russo)

- n. 3 displacement transducers for controlling the opening/closing of the cracks;
- n. 2 sensors for measuring the internal and external ambient temperature;
- n. 1 data acquisition unit; - Ultra narrow band modem for data transfer;
- software for visualising and storing data on a web server platform.

The monitoring results after one year show how the basement fracture has a cyclical behavior, with phases returning to their initial state and a residual, narrower return pattern. Fluctuations influence the result at the groundwater level, and dynamic stress patterns are exacerbated by climate change (*fig. 11, A-B*). Regular inspections ensure structural integrity, mitigating any accessibility risks. These data are significant, especially with the increased rainfall and considerable temperature fluctuations.
